Dairy Dreams
Site Inspection April 16, 2014

CAFO WPDES Compliance Report (06/23/2014)

Inspection Date: 04/16/2014

Operation: Dairy Dreams

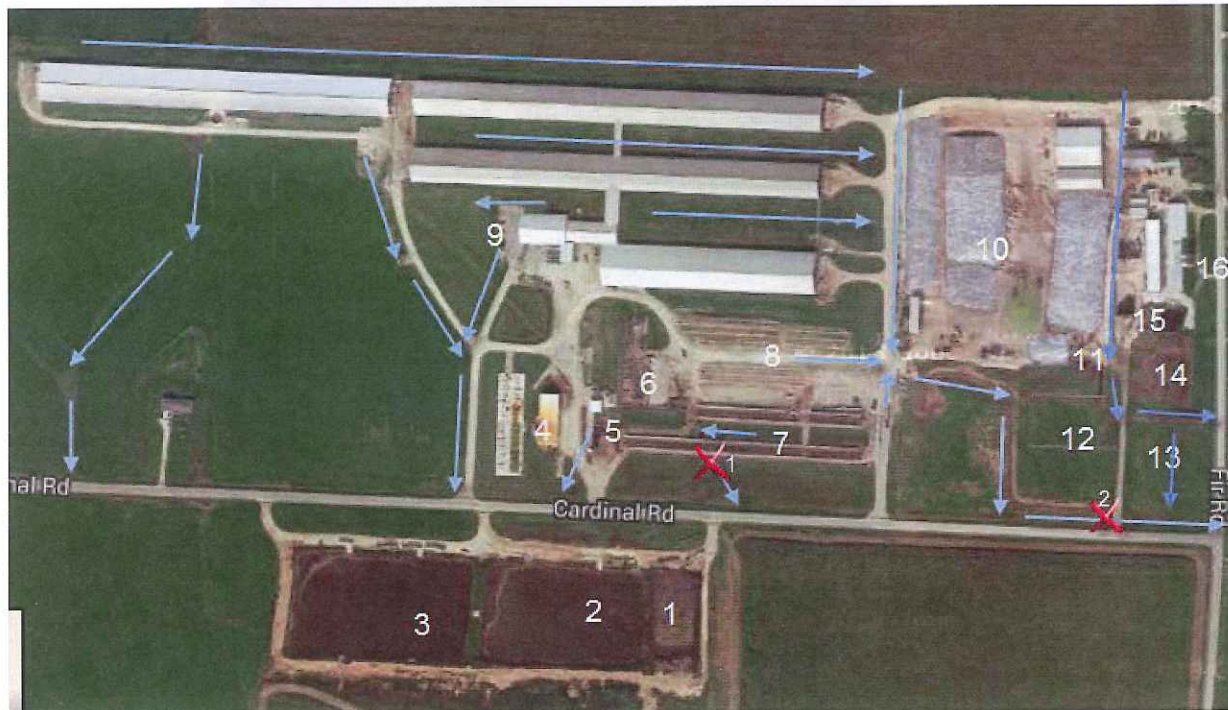
- 1- Manure Storage Pond Stage 1
 - 2- Manure Storage Pond Stage 2
 - 3- Manure Storage Pond Stage 3
 - 4- Digester
 - 5- Sand Separation System/Flume
 - 6- Concrete Solid Manure Stacking Area & Sand Lanes
 - 7- Super Hutch Area
 - 8- Calf Hutch Area
 - 9- Milking Parlor
 - 10- Feed Storage
 - 11- Feed Storage Runoff Collection & Pump
 - 12- VTA and Spreader Bar for Feed Storage Area
 - 13- VTA and Spreader Bar for Stormwater
 - 14- Abandoned Heifer Lot
 - 15- Manure Storage Pond (north east)
 - 16- Abandoned Heifer Barn
- Stormwater (SW) Diversions/Flow Direction
- ✗ Sample Point 1- Near Calf Hutch Area
- ✗ Sample Point 2- SW Through The Facility
